Institute of
Steel Structures

Newsletter
July 2023

National Technical University of Athens
School of Civil Engineering

Assessment of the Euripos Bridge

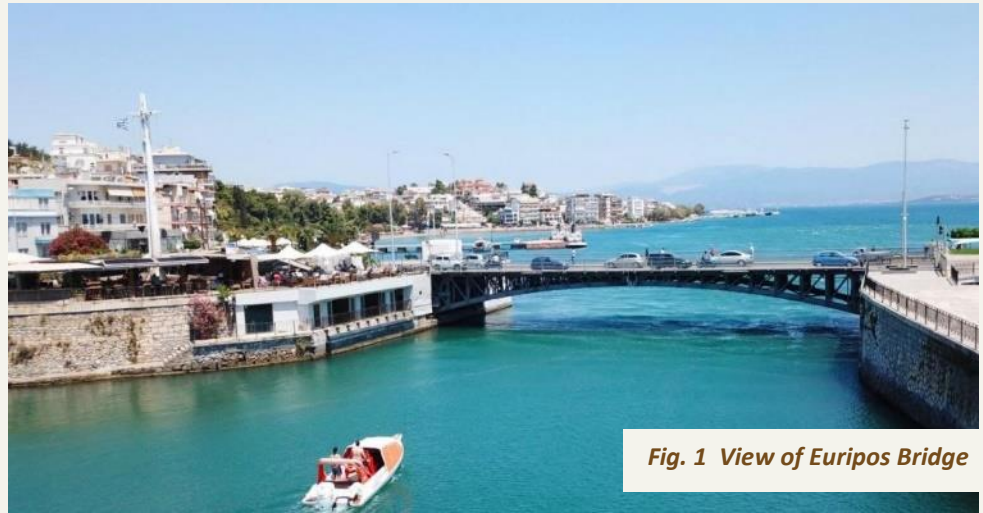
Fig. 1 View of Euripos Bridge

The Institute of Steel Structures NTUA has been granted a project to assess the steel riveted truss bridge over the 42 m wide strait of Euripos, Greece. The bridge has been in operation since 1962 and for three decades it was the only road connecting the Evia island, the 2nd largest in Greece, with the mainland.

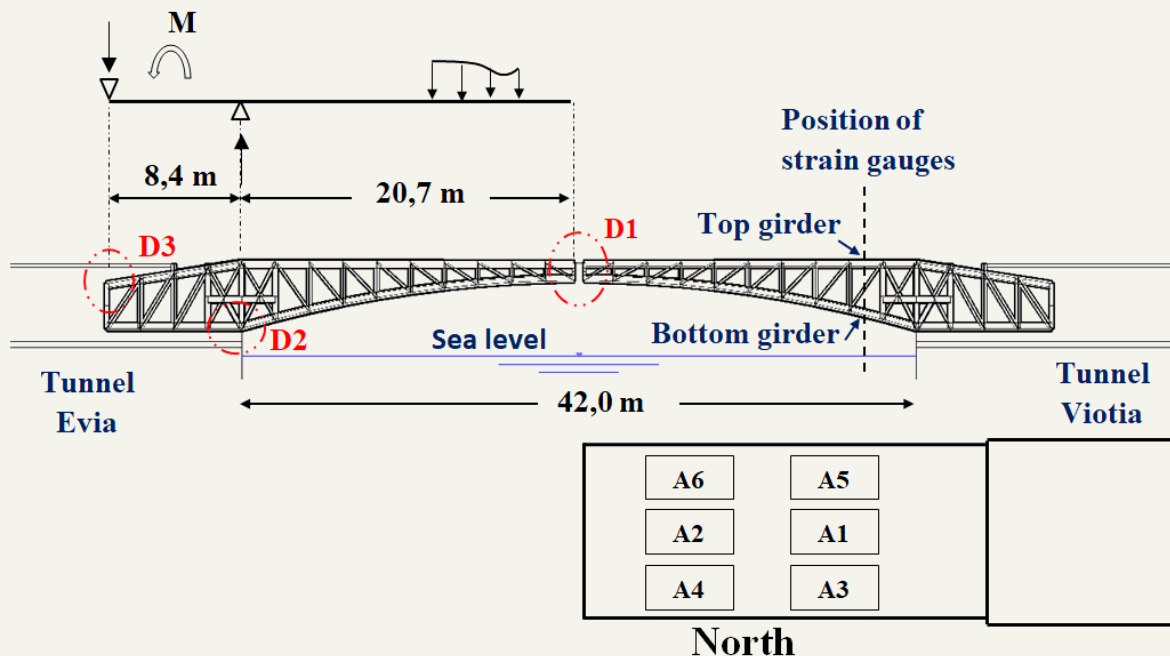
Fig. 2 Overview of the structural system

The strait is bridged by two mechanically movable girders that are connected in the middle of the span through pins (fig. 3). For the traffic loads, the structural system of each half is a 20.7m long cantilever with its moment support being provided by a pair of point bearings.

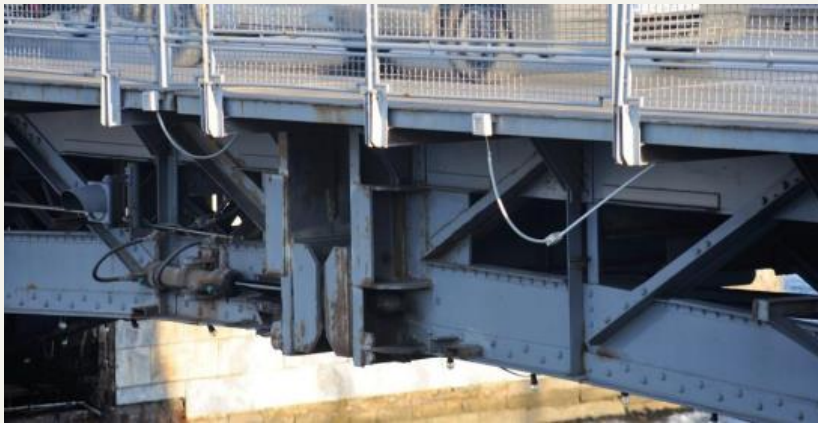
Fig. 3 Pin at the middle of the span (D1)

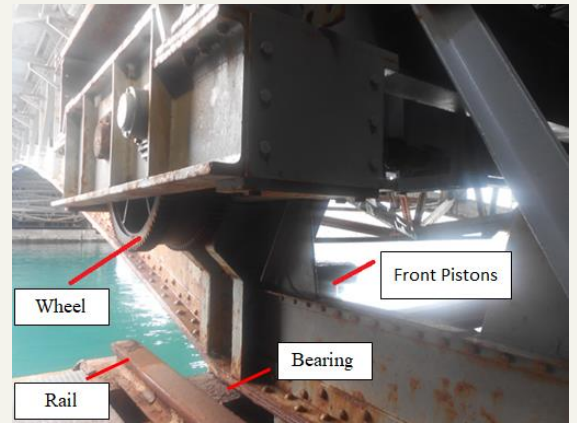
Fig. 4 Front support (D2)

The front support (fig. 4) is implemented by piles while the rear one (fig. 5) is realized by means of pistons using the concrete tunnel roof as counterweight. In order to

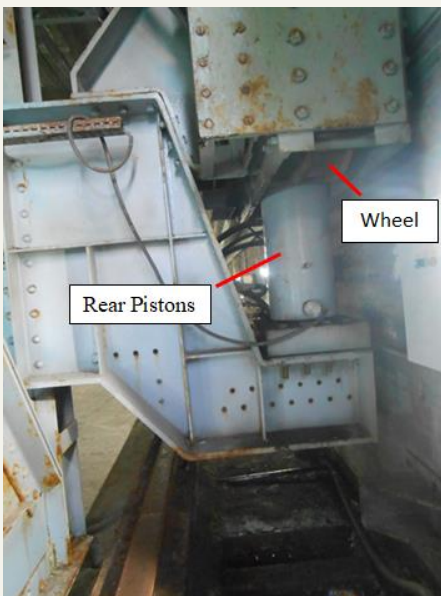
Fig. 5 Back support (D3)

allow the ships passage, the pins disengage, the structure descends using the pistons and each half rolls on the rails via wheels to withdraw into its tunnel. The width of the deck is 8,0m and there are fifteen secondary girders (axes A0÷A14) that are also formed as truss beams spaced every 2.10m along the length of the bridge (fig. 6).

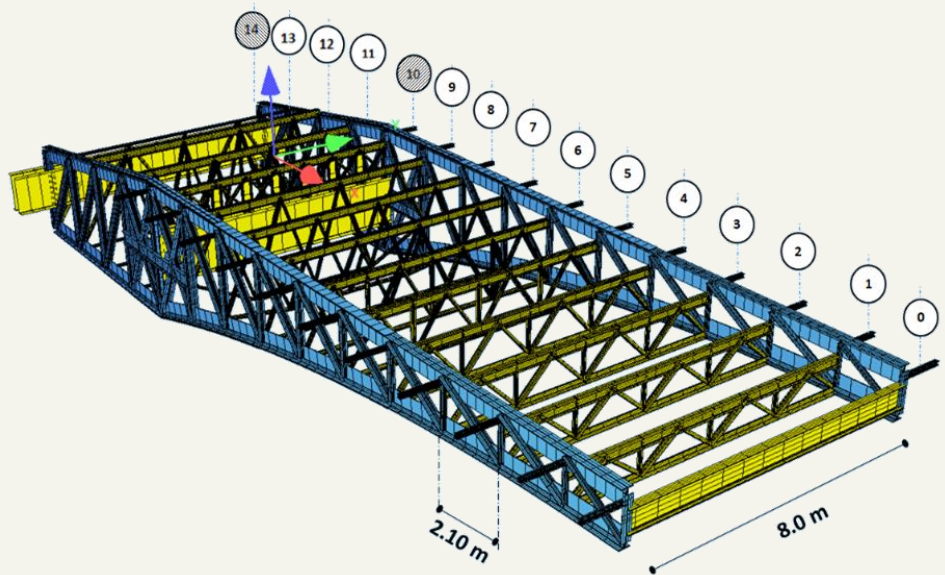
Fig. 6 Perspective view of the half bridge as a numerical model

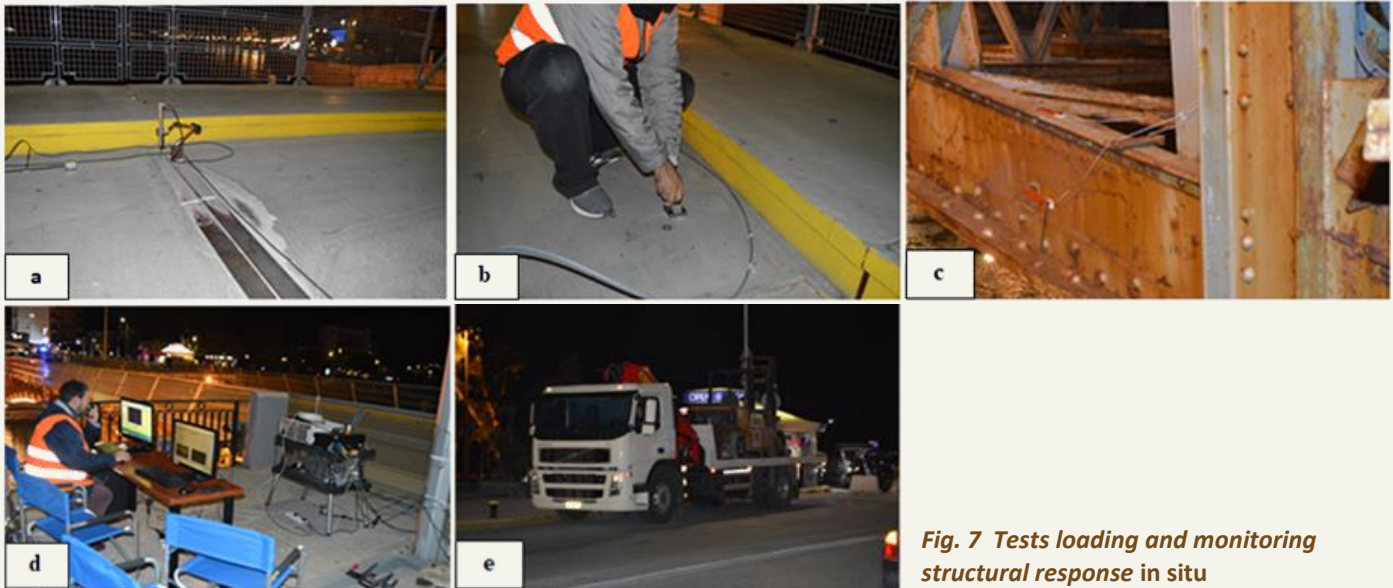
Fig. 7 Tests loading and monitoring structural response in situ

Subsequently, for validation of the detailed numerical simulation (FEM) of the bridge, measurements were carried out under static loading by means of a heavy vehicle (19t) at various deck positions (A1÷A6, fig. 2) with the central pins in disengaged phase, monitoring the structural response in situ. The model was validated in terms of free-end cantilever displacements

(two LVDTs, fig 7a), natural frequencies computed from measured deck accelerations (fig. 7b) and local internal forces of main members close to the front support as derived from strain gauge measurements (fig. 7c).

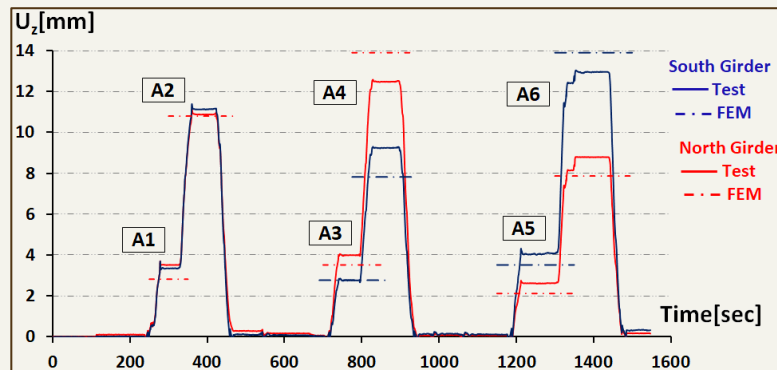
Fig. 8 Free-end cantilever vertical displacements [mm] of Viotia girder regarding the truck positions

A comparison of the measured vertical displacement and the corresponding predictions of the numerical simulation for both main girders (North, South) on Viotia coast are presented in figure 8, emphasizing that the test loadings were carried out in the time sequence defined by its serial number. In addition, the compressive axial force of the bottom flange of the northern Viotia girder for the various positions of the truck is shown (fig. 9).

It is observed that the numerical simulation is in good agreement with the experimental data and can reliably predict the static structural response, also assisting towards fatigue calculation for the determination of the remaining lifetime of the bridge. Combining the

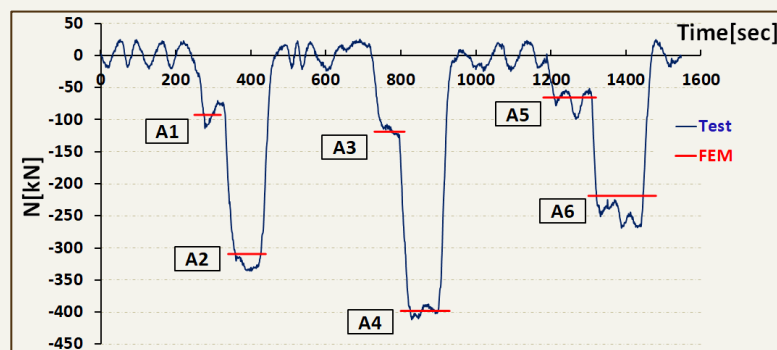
Fig. 9 Bottom flange of North Viotia girder axial force N[kN] for different truck positions

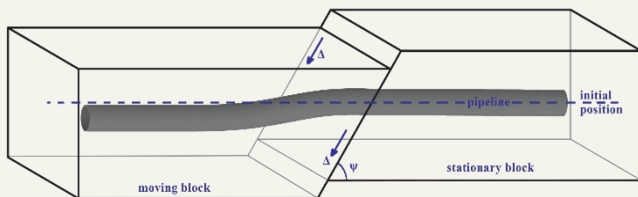
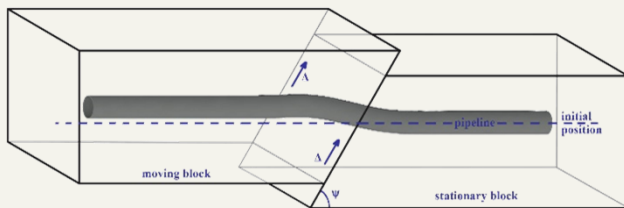
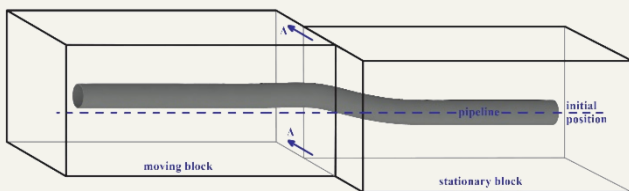
(a) pipeline deformation due to normal faulting

(b) pipeline deformation due to reverse faulting

(c) pipeline deformation due to strike-slip faulting

Fig. 1 Pipeline deformation caused by (a) normal, (b) reverse, and (c) strike-slip fault rupture (the left block is the moving and the right is the stationary one)

Seismic fault activation is the most catastrophic seismic-induced action on pipelines. In case of fault activation, the pipe is forced to follow the imposed ground displacement by developing excessive deformations that might threaten its structural and operational integrity.

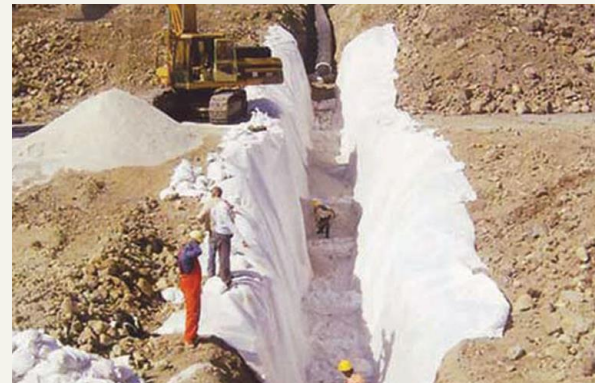
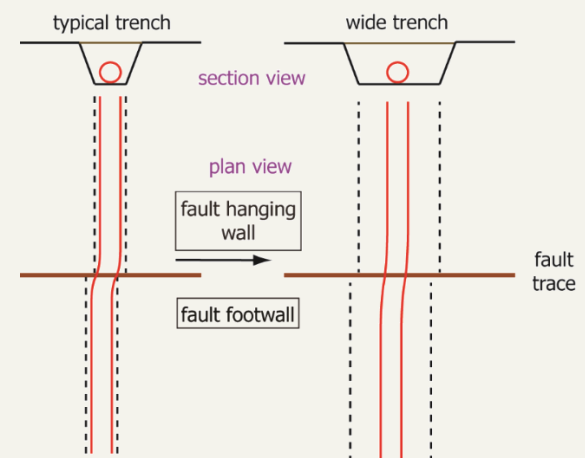
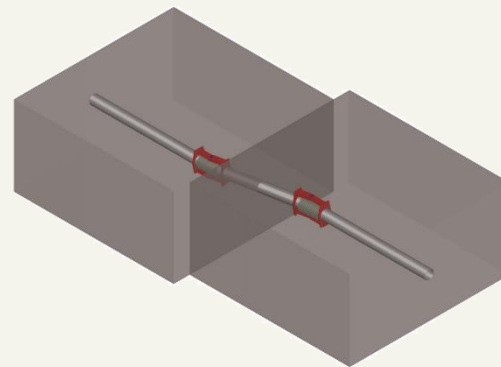
(a) Geotextile-lined trench

(b) Construction of a wider trench

(c) Introduction of flexible joints at the fault vicinity

Fig. 2 Seismic countermeasures for pipelines at fault crossings

(B) The reduction of the friction developed on the pipe-soil interface contributes to the reduction of pipe strains. This could be accomplished by trench backfilling with tire-derived aggregate that is a compressible material, use of geotextile-lined pipeline trenches (Fig. 2a), trench backfilling with loose granular soil (e.g., pumice), excavation of a wider trench for the pipeline to “freely” move in the trench (Fig. 2b), pipe isolation from ground displacements by placing the pipeline within concrete culverts and without backfilling material in the case of strike-slip faulting, and partial replacement of soil backfill with EPS geofoam blocks.

(C) Other measures that have been proposed or applied on a case-specific basis and can be classified neither as pipe strengthening nor as friction reduction. These measures include the use of a protective device that aims at reducing the potential of local buckling by applying external hydrostatic pressure to the pipeline at critical predefined locations, the change of pipe route with a very high radius bend to allow unrestrained pipe deformation, the introduction of flexible joints in the pipeline at the fault vicinity (Fig. 2c) to “absorb” pipe deformation and render pipe segments virtually undeformed and consequently unstrained, the use of field bends to relieve pipe strains under very specific conditions by taking advantage of bends’ flexibility, and the creation of a predefined buckling pattern that consists of localized deformation of the pipe wall at specified predefined locations aiming at controlling the pipe local deformation.

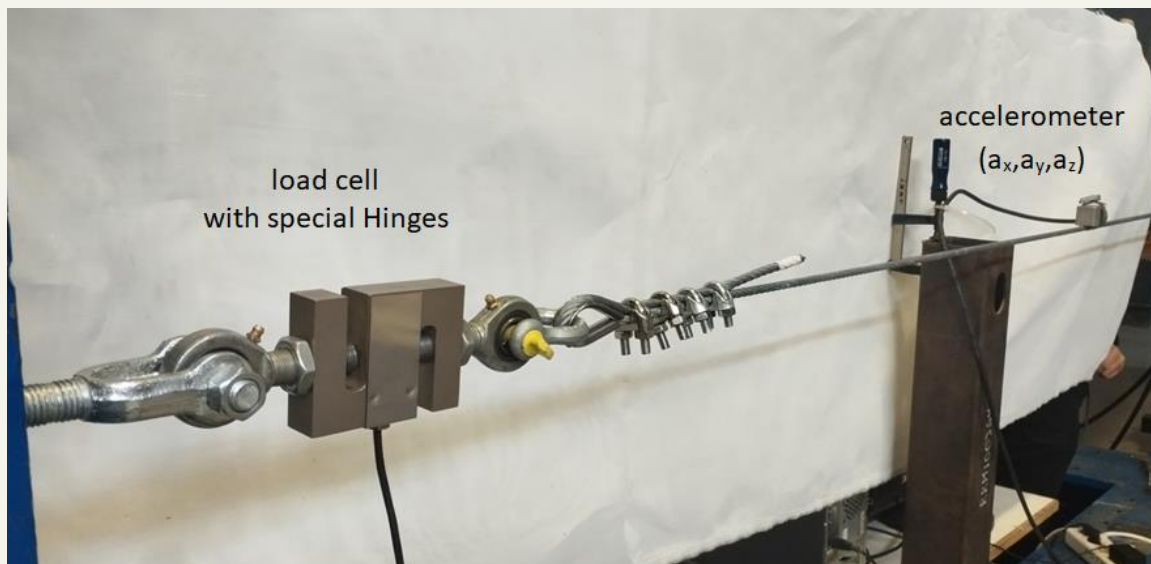
Fig. 1 Experimental setup

experimentally investigated at the Institute of Steel Structures. In particular, triggering free vibrations by hand excitation, the natural frequencies f (Hz) and cable tension T (kN) were simultaneously measured through a 3-axis accelerometer and a load cell.

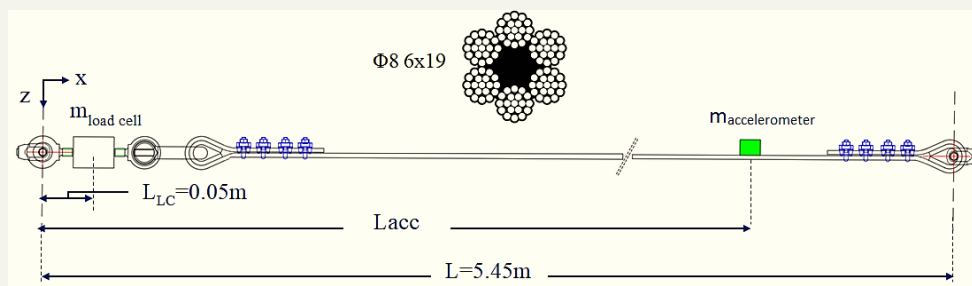
Fig. 2 Experimental setup

Table 1 shows the cable cross-sectional properties and describes the experimental setup (fig. 2), where $L=5.45\text{m}$ is the horizontal cable length, considered as

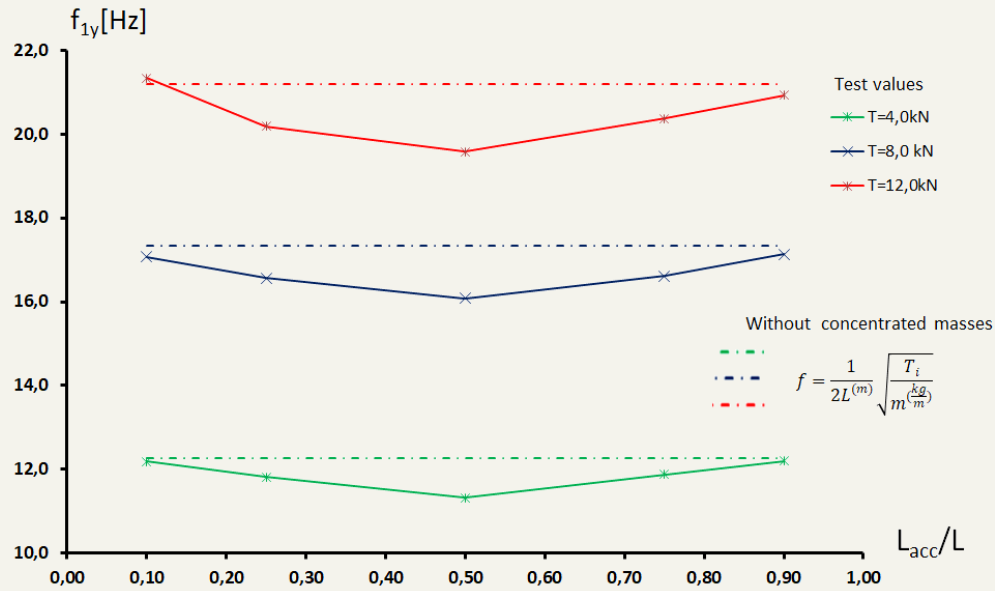
Fig. 3 Comparison of measured and theoretical values of out-plane natural frequency as functions of cable force and position of accelerometer

Due to the relatively short cable length, the presence of instrument masses affects the measurement of natural frequency. In figure 3, the test values of out-plane

natural frequency for several cable forces and accelerometer positions along the length of the cable are presented and compared to the theoretical values.

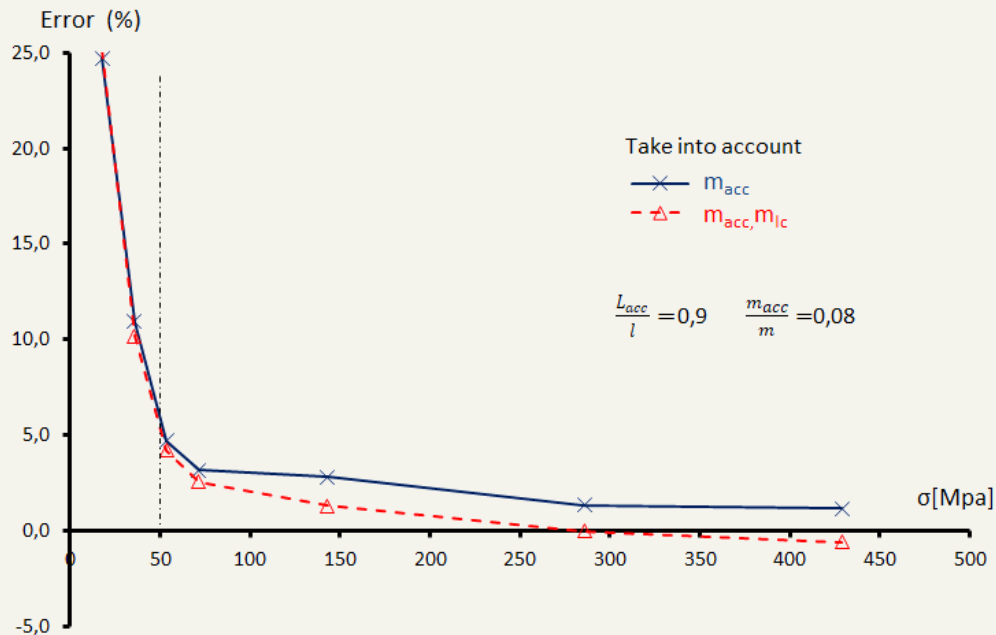
Fig. 4 Method error at several stress levels with accelerometer and with/without load cell mass effect

In figure 4 a lower stress level threshold can be detected, below which the relative error rate rapidly becomes unacceptable. Below this threshold, the effect of sag-span ratio and the variation of axial stiffness EI are not negligible and therefore the response is not governed by the simplified taut cable equation.

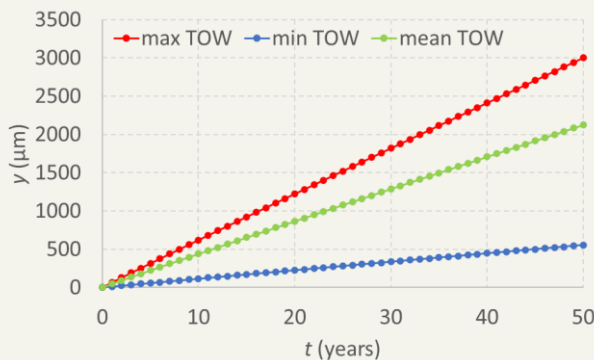
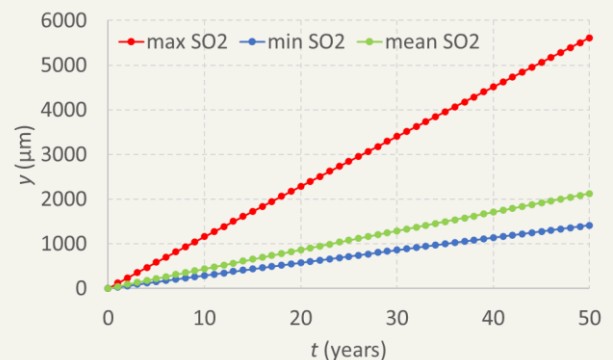
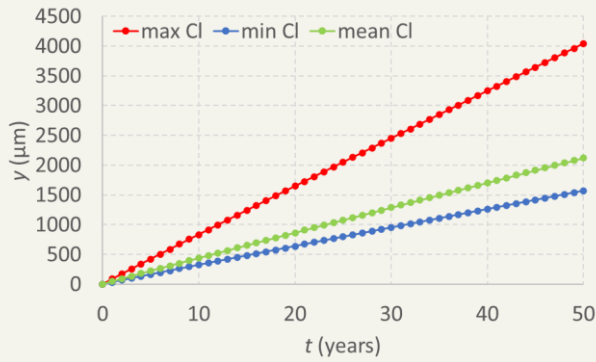
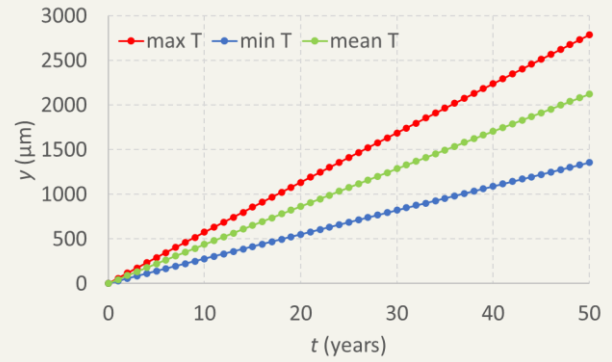
(a) Influence of time of wetness TOW

(b) Influence of sulfur dioxide concentration SO_2

(c) Influence of chloride deposition rate Cl

(d) Influence of air temperature T

Fig. 1 Influence of environmental parameters on corrosion loss with time

In order to assess the sensitivity of corrosion loss to each of the above four environmental parameters, a series of graphs is presented in Figures 1a to 1d, in each of which the minimum, mean and maximum values of one parameter are used, while for the other three parameters their mean value is adopted.

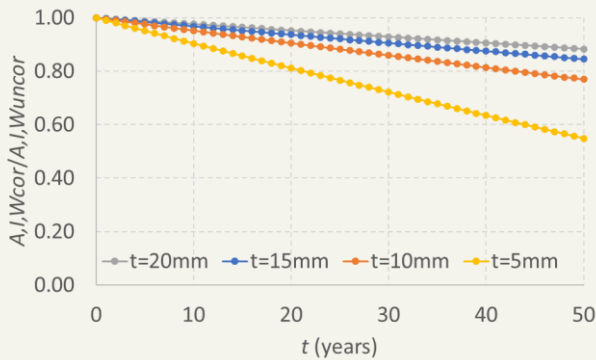
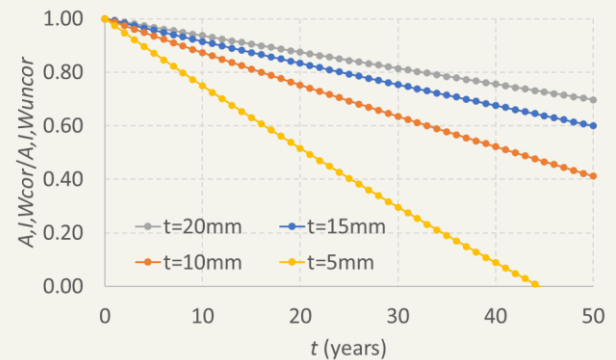
(a) Mean values of all environmental parameters

(b) Max value of SO_2 and mean values of other parameters

Fig. 2 Influence of corrosion on degradation of inertial characteristics of hollow sections

For the corrosion loss values calculated for the mean values of all 4 environmental parameters, the cross-section area, moment of inertia and elastic modulus ratio of corroded to uncorroded section varies with time as presented in Figure 2a as function of cross section thickness. The same effect for the maximum value of SO_2 and the mean values of the other environmental parameters is illustrated in Figure 2b.

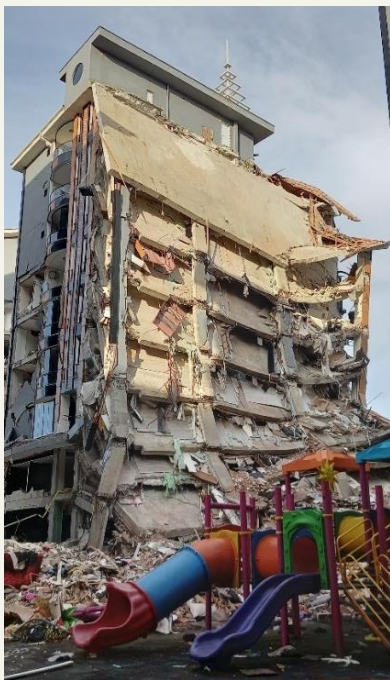
Fig. 2 Partial collapse of a 9-storey flat slab RC building, Adiyaman

The vast majority of the structures that were assessed during the mission was masonry and reinforced concrete (RC), with the latter being the main structural material for modern structures. The extent of the damage can be attributed to several causes. First and foremost, the magnitude of the two back-to-back events, but also the high number of old buildings with hardly any seismic design (e.g. smooth reinforcing bars or insufficient transverse reinforcement). The dense construction in the cities led in many cases to severe pounding, where the buildings that collapsed destroyed parts of the neighbouring structures and even cut columns or shear walls. Certain structural systems (like the flat slab-column with no beams, see Figure 2) seem to have performed quite poorly.

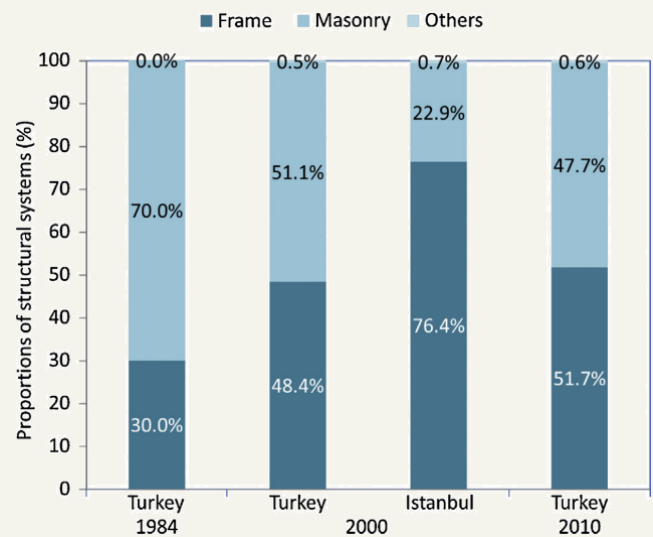
Fig. 3 Distribution of buildings by their structural system (Gunes 2015, TUIK)

As far as steel structures are concerned, not many conclusions could be derived, as structural steel is not very popular in the affected regions, but also in Turkey in general. In fact, as it can be seen in Figure 3, types of structures excluding RC and masonry and including structural steel, are less than 1% of the total building stock.

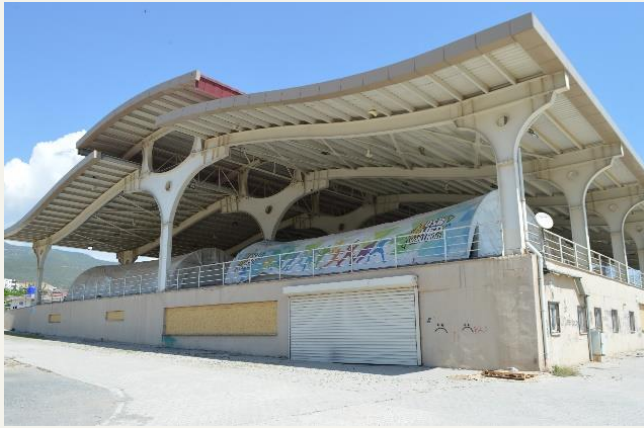
Fig. 4 Roof structure of the municipal market, Nurdaği

Roof structures behaved very well, which is normal for such lightweight structures (Figure 4). In addition, as they remained safe and fully functional, they were used to cover tents providing civil services, a function which was of paramount importance in the regions that were hit.

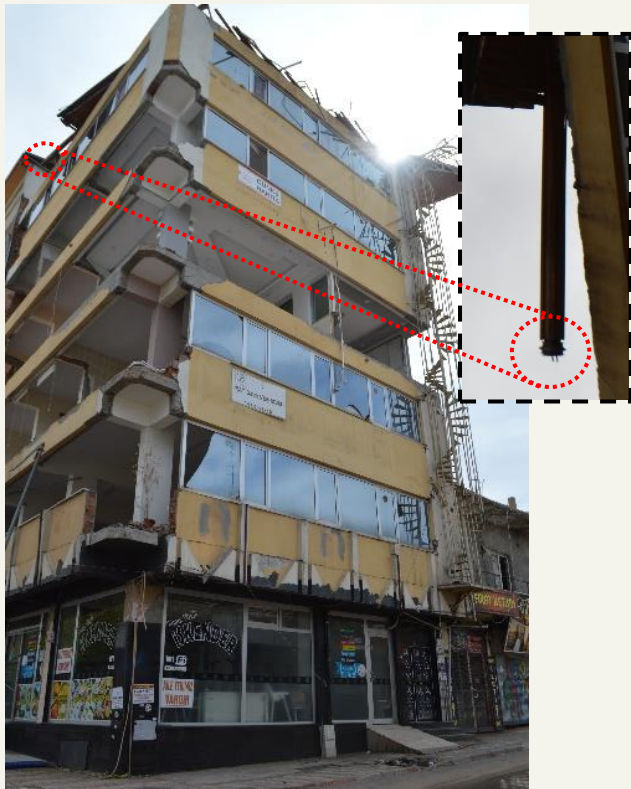
Fig. 5 Total collapse of top floor steel roof due to insufficient anchorage and bracing, Pazarcık

A very common practice was for the last floor of multi-storey RC buildings to be covered with a steel roof. Even in cases where the main buildings were heavily damaged and despite the increased spectral acceleration at the top, these roofs behaved quite well, especially if they were connected to a concrete part in the centre of the top floor. However, a few of those structures failed, due to the lack of adequate bracing and insufficient anchorage of the columns (Figure 5).

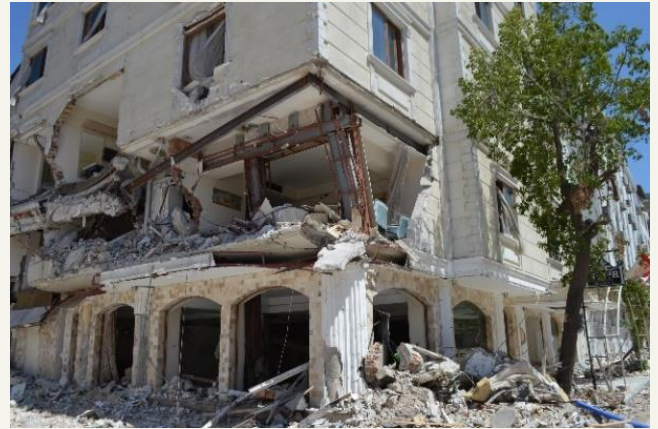
Fig. 6 Retrofitted RC building with steel members, Antakya

A RC building which was retrofitted with steel frames in its second storey was found in Antakya. Although the building did not collapse, the plasticity demand was mostly concentrated in the second floor. Thus, the steel members suffered significant permanent deformation and the non-structural elements were completely destroyed, probably deeming the building beyond repair (Figure 6).

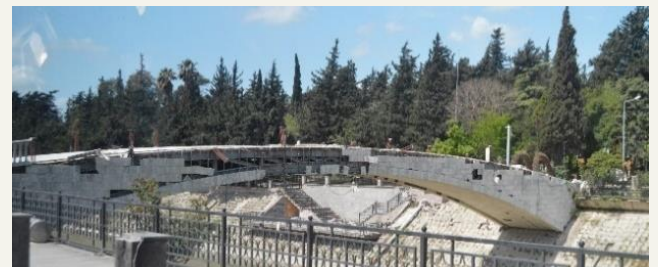
Fig. 7 Pedestrian truss bridge with non-structural damage, Antakya

As far as bridges are concerned, no significant damages were observed other than the activation of the seismic stoppers and small permanent deformations of the bearings. This was even better for steel bridges, which mostly remained fully functional, except of damage to secondary members, façade and parapets (Figure 7). Most of these cases were recorded in Antakya, which was probably the city that was most severely hit on 6th February.
